AI POWERED SEALANT INSPECTION

Industry : Automotive
Client : **Bajaj Auto Limited**

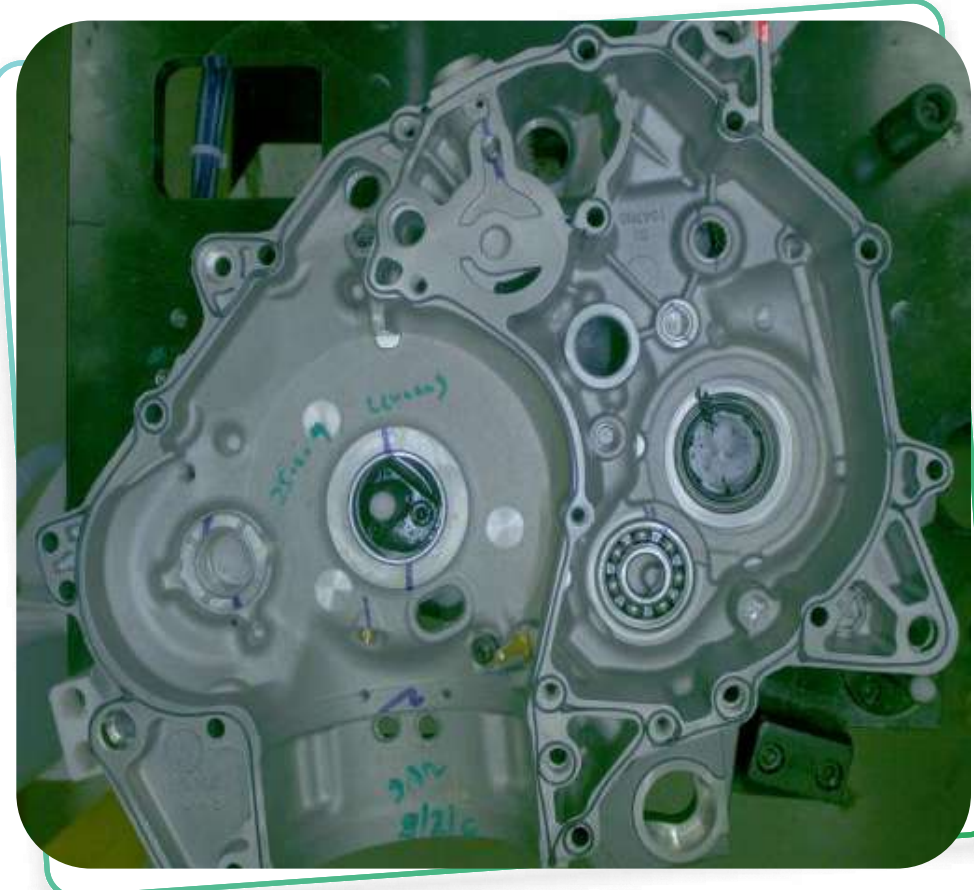
Tag: **Good** Score: **100**

After implementing the SwitchOn DeepInspect System, Bajaj achieved 99.5% accuracy in various sealant inspections, including continuity, presence/absence, and thickness, significantly reducing manual effort. This enhancement improved the performance of Bajaj motorbikes using crankcase SKUs.

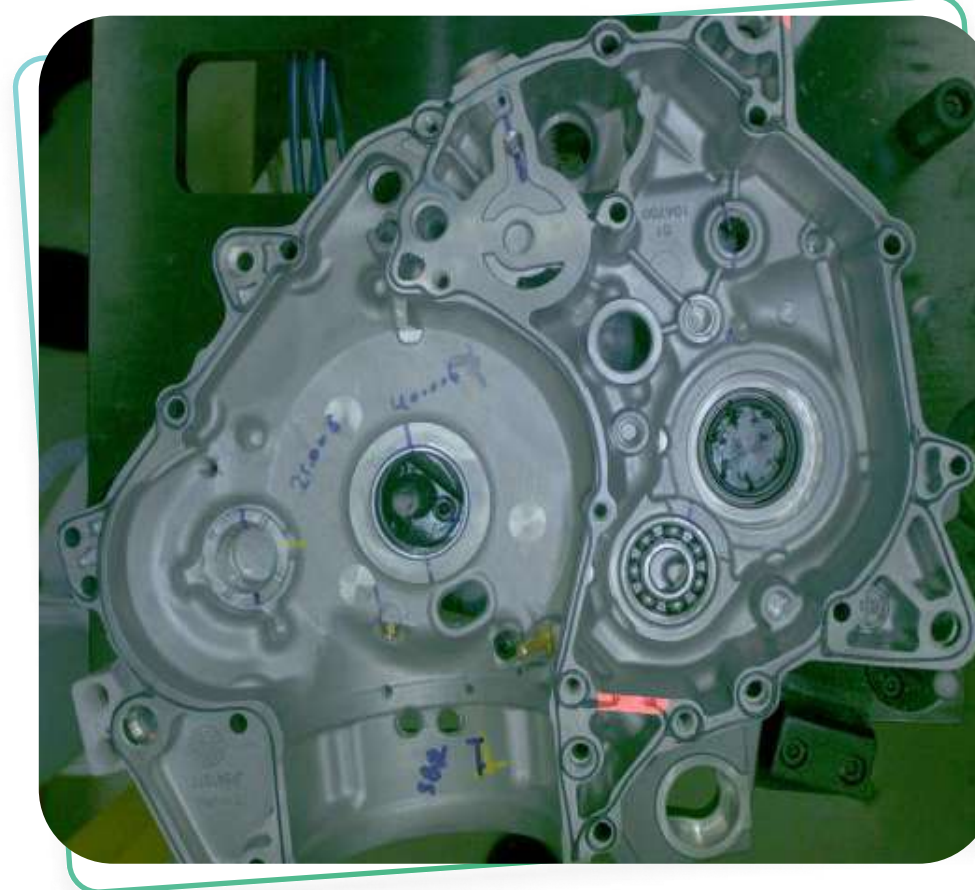
Tag: **Not Good** Score: **84**
